## **Damage of Canopies in Gas Stations due to Hurricanes Katrina and Rita**

**Luis A. Godoy, Ph. D.**

**Augusto Poitevin, P. E.**

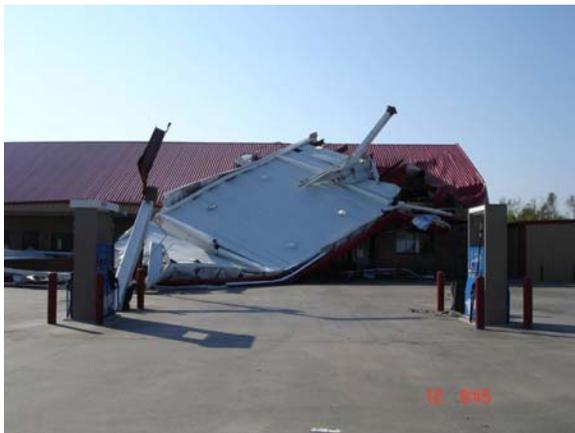
**Figure 2a. Exxon Gas Station, Road 365 and Labelle Road, Hillerbrandt, TX (Photograph taken on October 12).**

In the first Exxon station (shown in Figure 2), the canopy was pulled out from its foundation by wind uplift and the columns were lifted except for one. The complete canopy was thrown by the wind against the gas station building, which was some 20 meters away from the original location of the canopy and produced much damage, as seen in Figure 2a. The main reason for this failure seems to be a poor foundation construction, with the columns being buried only 0.30 m (Figure 2b). The station was located in open terrain.

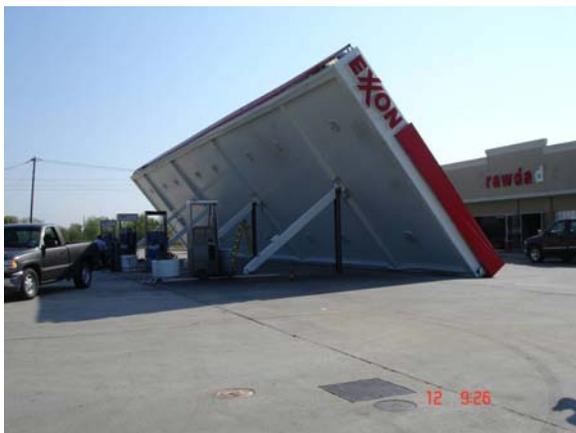
**Figure 3a. Exxon Gas Station in Road 365, Hillerbrandt, TX, about half mile from the one of Figure 2. (Photograph taken on October 12).**

Failure of the canopy in the second Exxon station, shown in Figure 3, was different. The foundation was such that the columns were buried about 1 m in the concrete slab, and resisted well the winds. The failure mode was associated to plastic hinges forming at the base of the columns (Figure 3b), and the canopy rotated as a mechanism, as shown in Figure 3a. The conditions of exposure to wind were similar in the two Exxon stations. A common denominator was that there is no frame action in the structure (since the columns are not attached to beams using rigid connections) with the consequence that the columns work as individual components.

Case 1. This case models the canopy shown in Figures 1-3. Figure 13b shows the deflected shape of the structure for loads acting in its weakest direction. Under the scenario of lateral pressures only, the stress ratios are shown in Figure 13c, and for the external columns they reach high values of 0.92. In the second wind pressure scenario this ratio becomes 1.3. The analysis confirms the overstress on the canopy columns, indicating that failure could have occurred in the mode shown in Figure 3a.

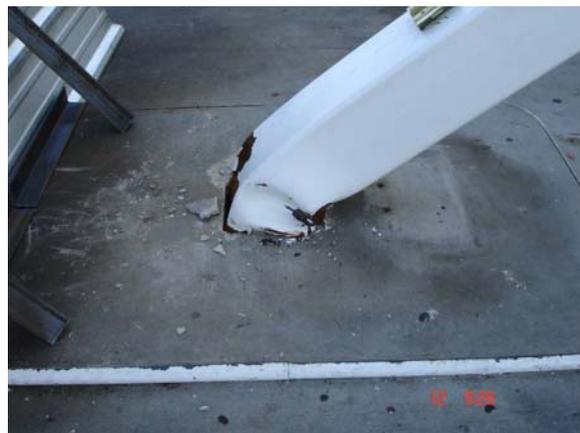
**Figure 3b. Exxon Gas Station, Hillerbrandt, TX. Plastic hinges formed at the base of the columns. (Photograph taken on October 12).**

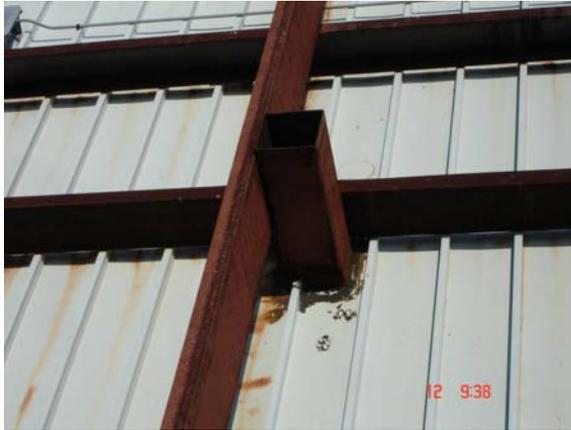
**Figure 3c. Exxon Gas Station, Hillerbrandt, TX. There was effective frame action.  
(Photograph taken on October 12).**

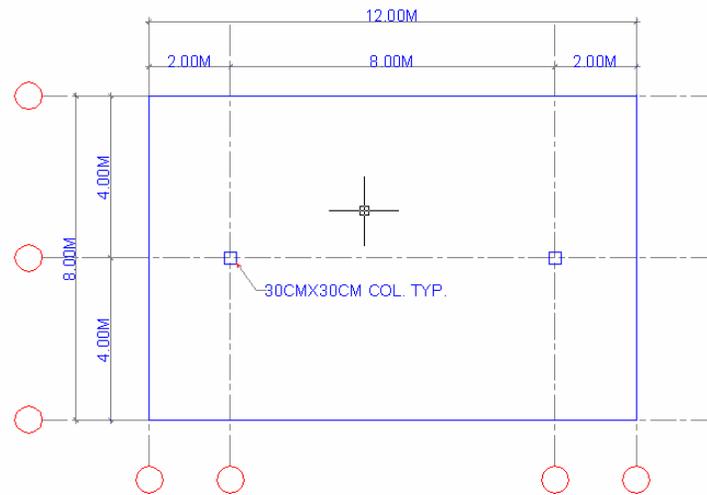
**Figure 4a. Chevron gas station in Vidor, TX (Road 105 and HW 10).**

Another failure mode was observed in a Chevron station in Vidor, TX, shown in Figure 4. This canopy was supported by just two aligned columns. The structure failed at its weakest point, which was the base of the columns. This section at the base had extensive corrosion (Figure 4c) and could not take moments or tensile stress as those required to provide equilibrium under wind pressures. The canopy was separated from its foundation and was found across the road some 20 m away from its original location, in an inverted position (Figure 4b). The cause of this failure should be associated to poor maintenance of the structure. The base of the columns was covered by a metal box and probably was never inspected to verify if corrosion was taking place. Across HW 10, there were two other gas stations that did not show any damage in their canopies and were selling gas at the time of the mission.

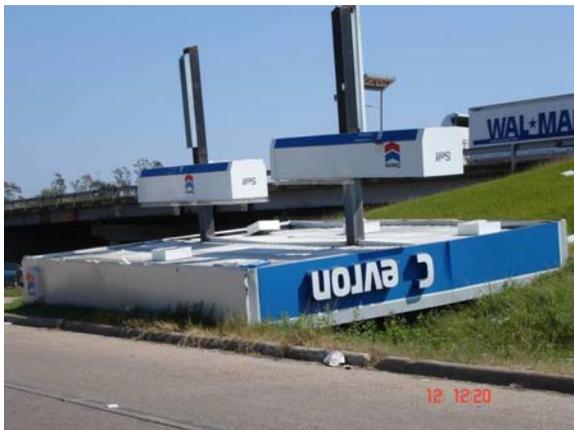
**Figure 4b. Chevron gas station in Vidor, TX  
(Photograph taken on October 12).**

Case 2. The structure of Figure 4 has also been modeled using ETABS and two wind pressure-scenarios. The deflected shape is shown in Figure 14b for pressures in the strong direction of the structure. The stress ratio for lateral pressure in the weak direction is 0.65 on the columns, but as suction is included, the stresses increase to 0.99. The stress ratio on the existing columns was very close to the allowable stress permitted by code. This is a case of overstressed columns, which on account of the corrosion effect identified in Figure 4c, would explain the collapse observed in Figure 4b, in which the canopy was completely separated from the foundation system.

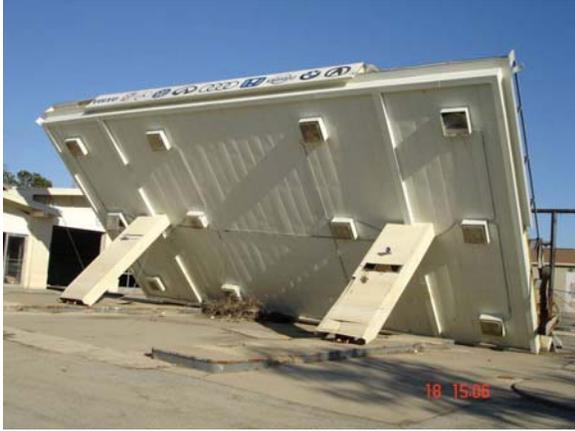
Another example of corrosion at the base of the columns was found in a gas station in Road 39, Chalmette, LA (Figure 5). Here the connection between the columns and the roof were effective and the structure rotated as a rigid body. Figure 5b shows the signs of corrosion at the base. Again, this column was covered with a metal box (presumably to protect it from the circulating cars) so that it was not visible. The rain water of the roof is usually diverted to the columns and this is a major cause of corrosion at the base.

**Figure 5a. Road 39, Chalmette, LA. The connection between column and roof was effective. (Photograph taken on November 18).**

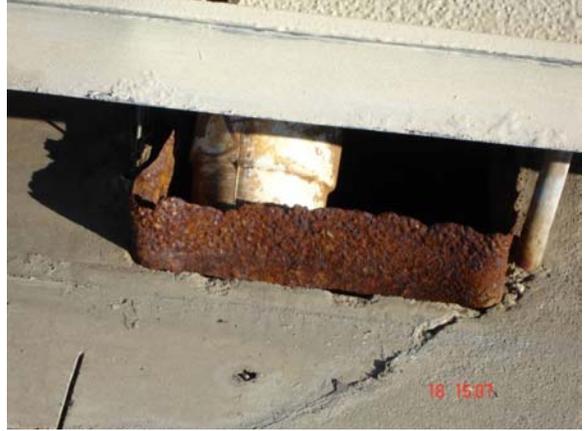
**Figure 5b. Road 39, Chalmette, LA. Evidence of corrosion at the base of the columns. (Photograph taken on November 18).**

- A second lesson is that maintenance is crucial to maintain the integrity of the canopy, especially in relation to corrosion of the columns at the base. This is a weak point and at the same time it is vulnerable to water and moisture action.

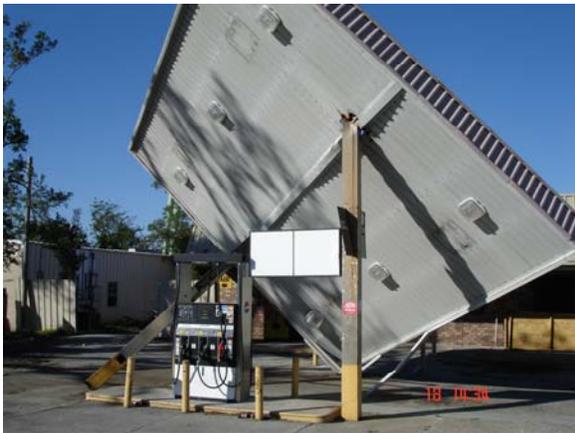
Failure of the canopy in St. Bernard, LA (Figure 6a), can also be attributed to corrosion at the base of one column (Figure 6.b). The canopy had two columns; the second one did not fail at the base, but there was a failure of the joint with the beams as the roof rotated and collapsed.

**Figure 6a. St. Bernard, LA. One of the columns failed due to plasticity. (Photograph taken on November 18).**

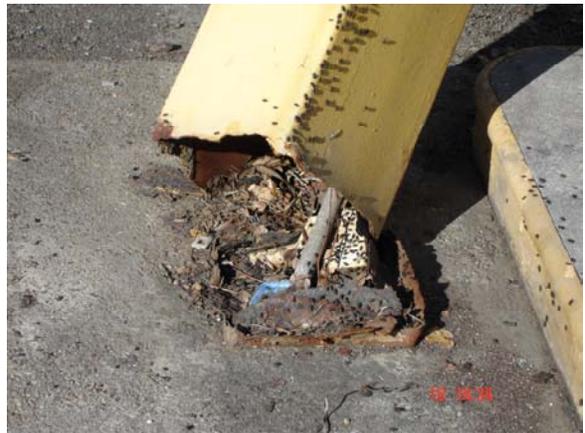
**Figure 6b. St. Bernard, LA. One of the columns had extensive corrosion at the base. (Photograph taken on November 18).**

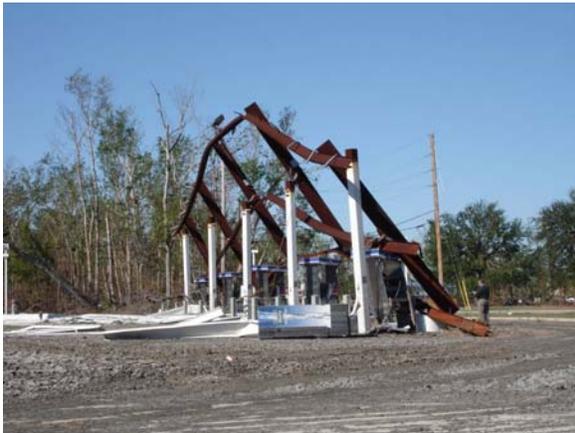
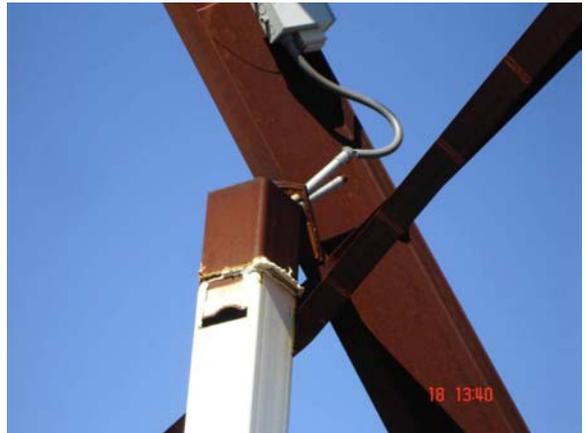
**Figure 7a. Gas Station in Violet, LA. (Photograph taken on November 18).**

The canopy of the Pure gas station in Violet, LA, close to New Orleans, is shown in Figure 7. The overall dimensions of the canopy were  $50 \times 6\text{m}$  in plan. It was constructed using five columns with  $0.25 \times 0.25\text{m}$  cross section, with spacing between the columns of 10m. Figure 7a shows that the columns did not fail and are still standing after hurricane Katrina, but there was no frame action, so that the roof was pulled out.

- A first lesson learned from the collapses is that canopies should be designed as frame structures, with proper rigid joint action being provided between the columns and the beams. This was not the case in most canopies for which we had access to observe the roof from the top.

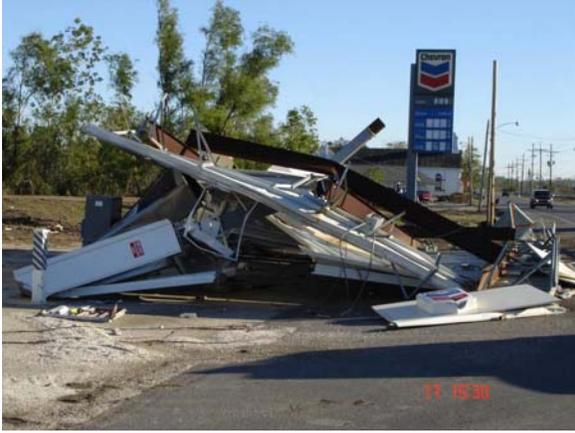
Figure 8a. Chevron gas station in Meraux, LA. (Photograph taken on November 17).

Hurricane Katrina destroyed the Chevron gas station in Meraux, LA (Figure 8). The overall dimensions were 16×8m in plan, with two columns at 12.5m, 0.25×0.25m cross section and 6.3mm (1/4in) thickness. Again, the columns did not have a proper connection with the roof beams.

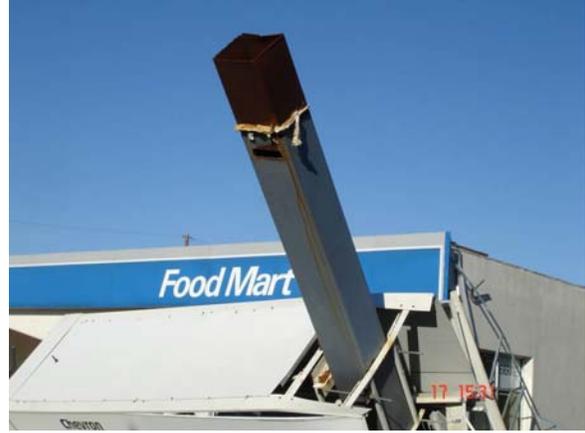
Figure 8b. Chevron gas station in Meraux, LA. The columns did not have connection with the roof. (Photograph taken on November 17).

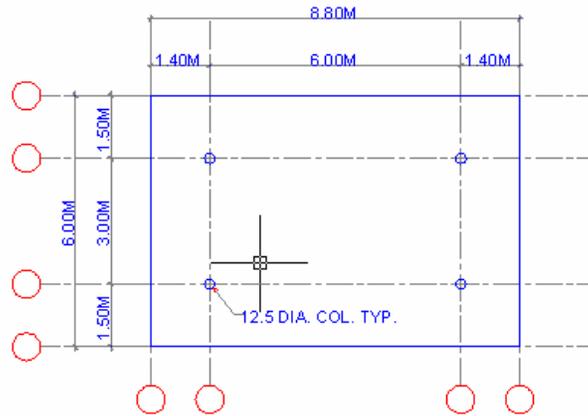
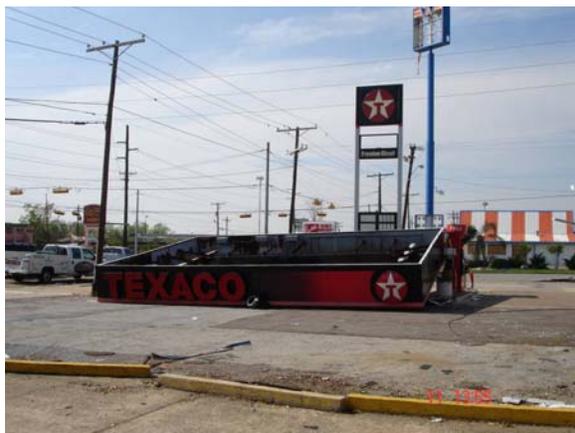
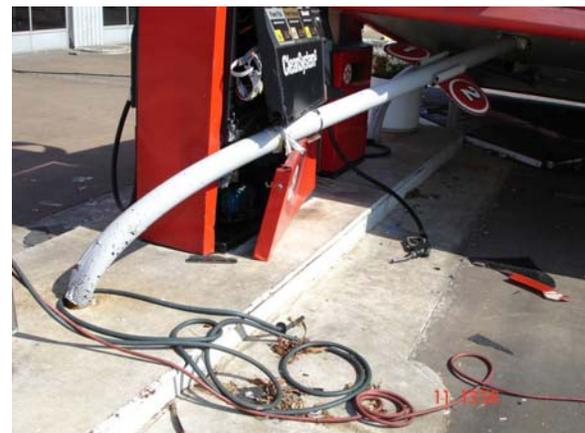
Figure 9a. Texaco gas station in Port Arthur, TX (39<sup>th</sup> Ave.)

The Texaco station in 39th Road, Port Arthur, TX (Figure 9) collapsed due to failure of the circular columns, initially in a sway mode. This seems to be a design problem, with extremely weak columns that are not capable of withstanding lateral forces. The structure collapsed on top of the gas pumps, producing their destruction (Figure 9a). The beams in the roof seem to be much stronger than the columns, but there is no connection between columns and beams.

Case 3. The third case investigated is a model of the canopy shown in Figure 9, with four columns. The structure was analyzed in the strongest direction in view of the failure mode observed in Figure 9. Under lateral pressures, the stress ratio on the columns was 1.21, whereas this ratio increased to 1.50 under the assumptions of uplift on the roof. All the columns buckled sideways in one direction. This is clearly a deficient design in terms of providing enough resistance to withstand the applied loads. Specifically, the tubular columns employed are too weak and can only take gravity loads.

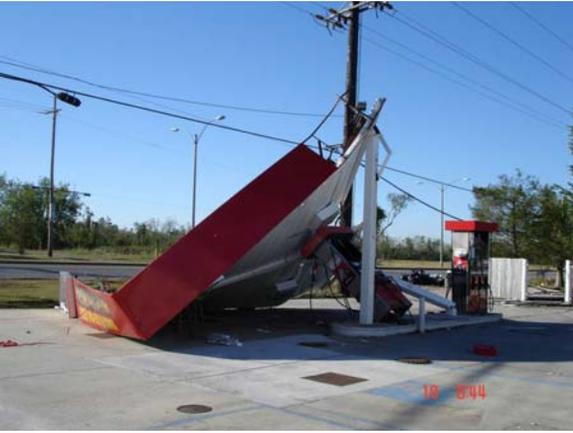
**Figure 10a. Road 90 and Wright, New Orleans area, LA. (Photograph taken on November 18)**

A collapsed small canopy was observed in Road 90 and Wright St., New Orleans area (Figure 10). The overall dimensions are 8×8m in plan, with two 0.20×0.20m columns at 4.1m from each other. The beam-column connection did not fail, and fracture failure occurred at the base of one column (Figure 10c). The purlings were constructed hanging from the beams (Figure 10b). All elements were taken by screws.

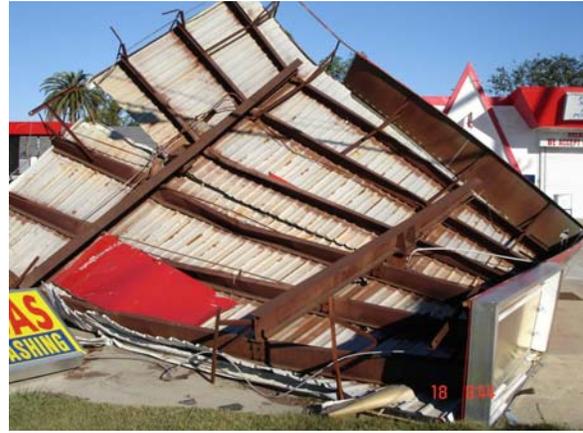
**Figure 10b. Road 90 and Wright, New Orleans area. Purlings hang from the beams. (Photograph taken on November 18)**

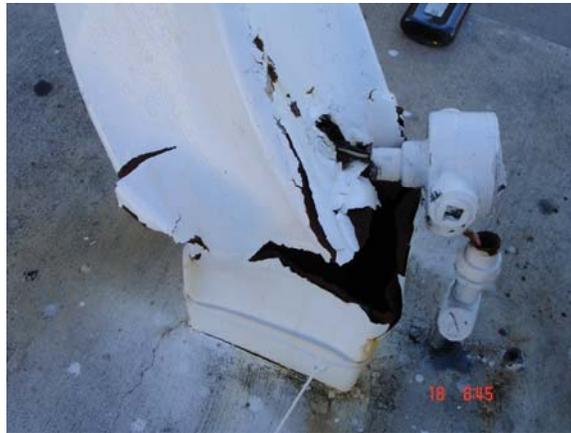
**Figure 10c. Road 90 and Wright, New Orleans area. Fracture at the base. (Photograph taken on November 18).**

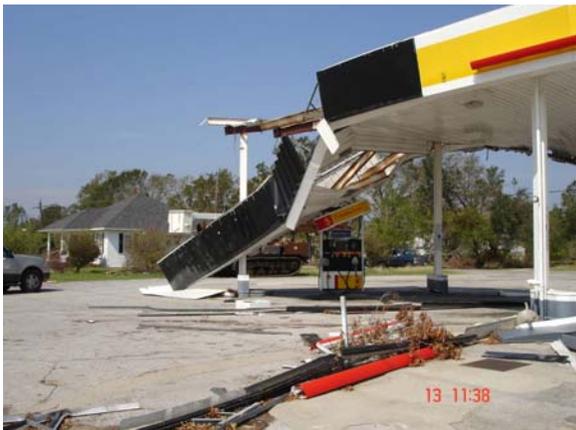
**Figure 11. Port Arthur, TX. (Photograph taken on October 13).**

Partial collapse of a canopy was identified in a Shell station in Port Arthur, TX (Figure 11). This was a station built some 20 years ago. The columns remained standing, and the roof collapsed by punching. Clearly, there is no frame action in the canopy, as the beams were detached from the columns. Other stations close to this one did not show any significant damage.

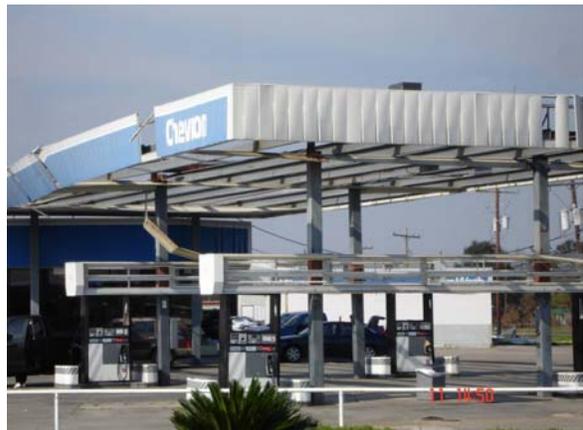
**Figure 12. Port Arthur, TX, Chevron gas station (Photograph taken on October 11).**

Other forms of damage were identified in the roof of canopies, as shown in the Chevron station, Port Arthur, TX, in Figure 12. Here the structure remained in good shape, and it was the plates and the sides of the roof that were damaged. The station was operating at the time of the mission..
